U. S. S. PRINCETON (CVL23)

LOSS IN ACTION

BATTLE FOR LEYTE GULF

WAR DAMAGE REPORT No. 62

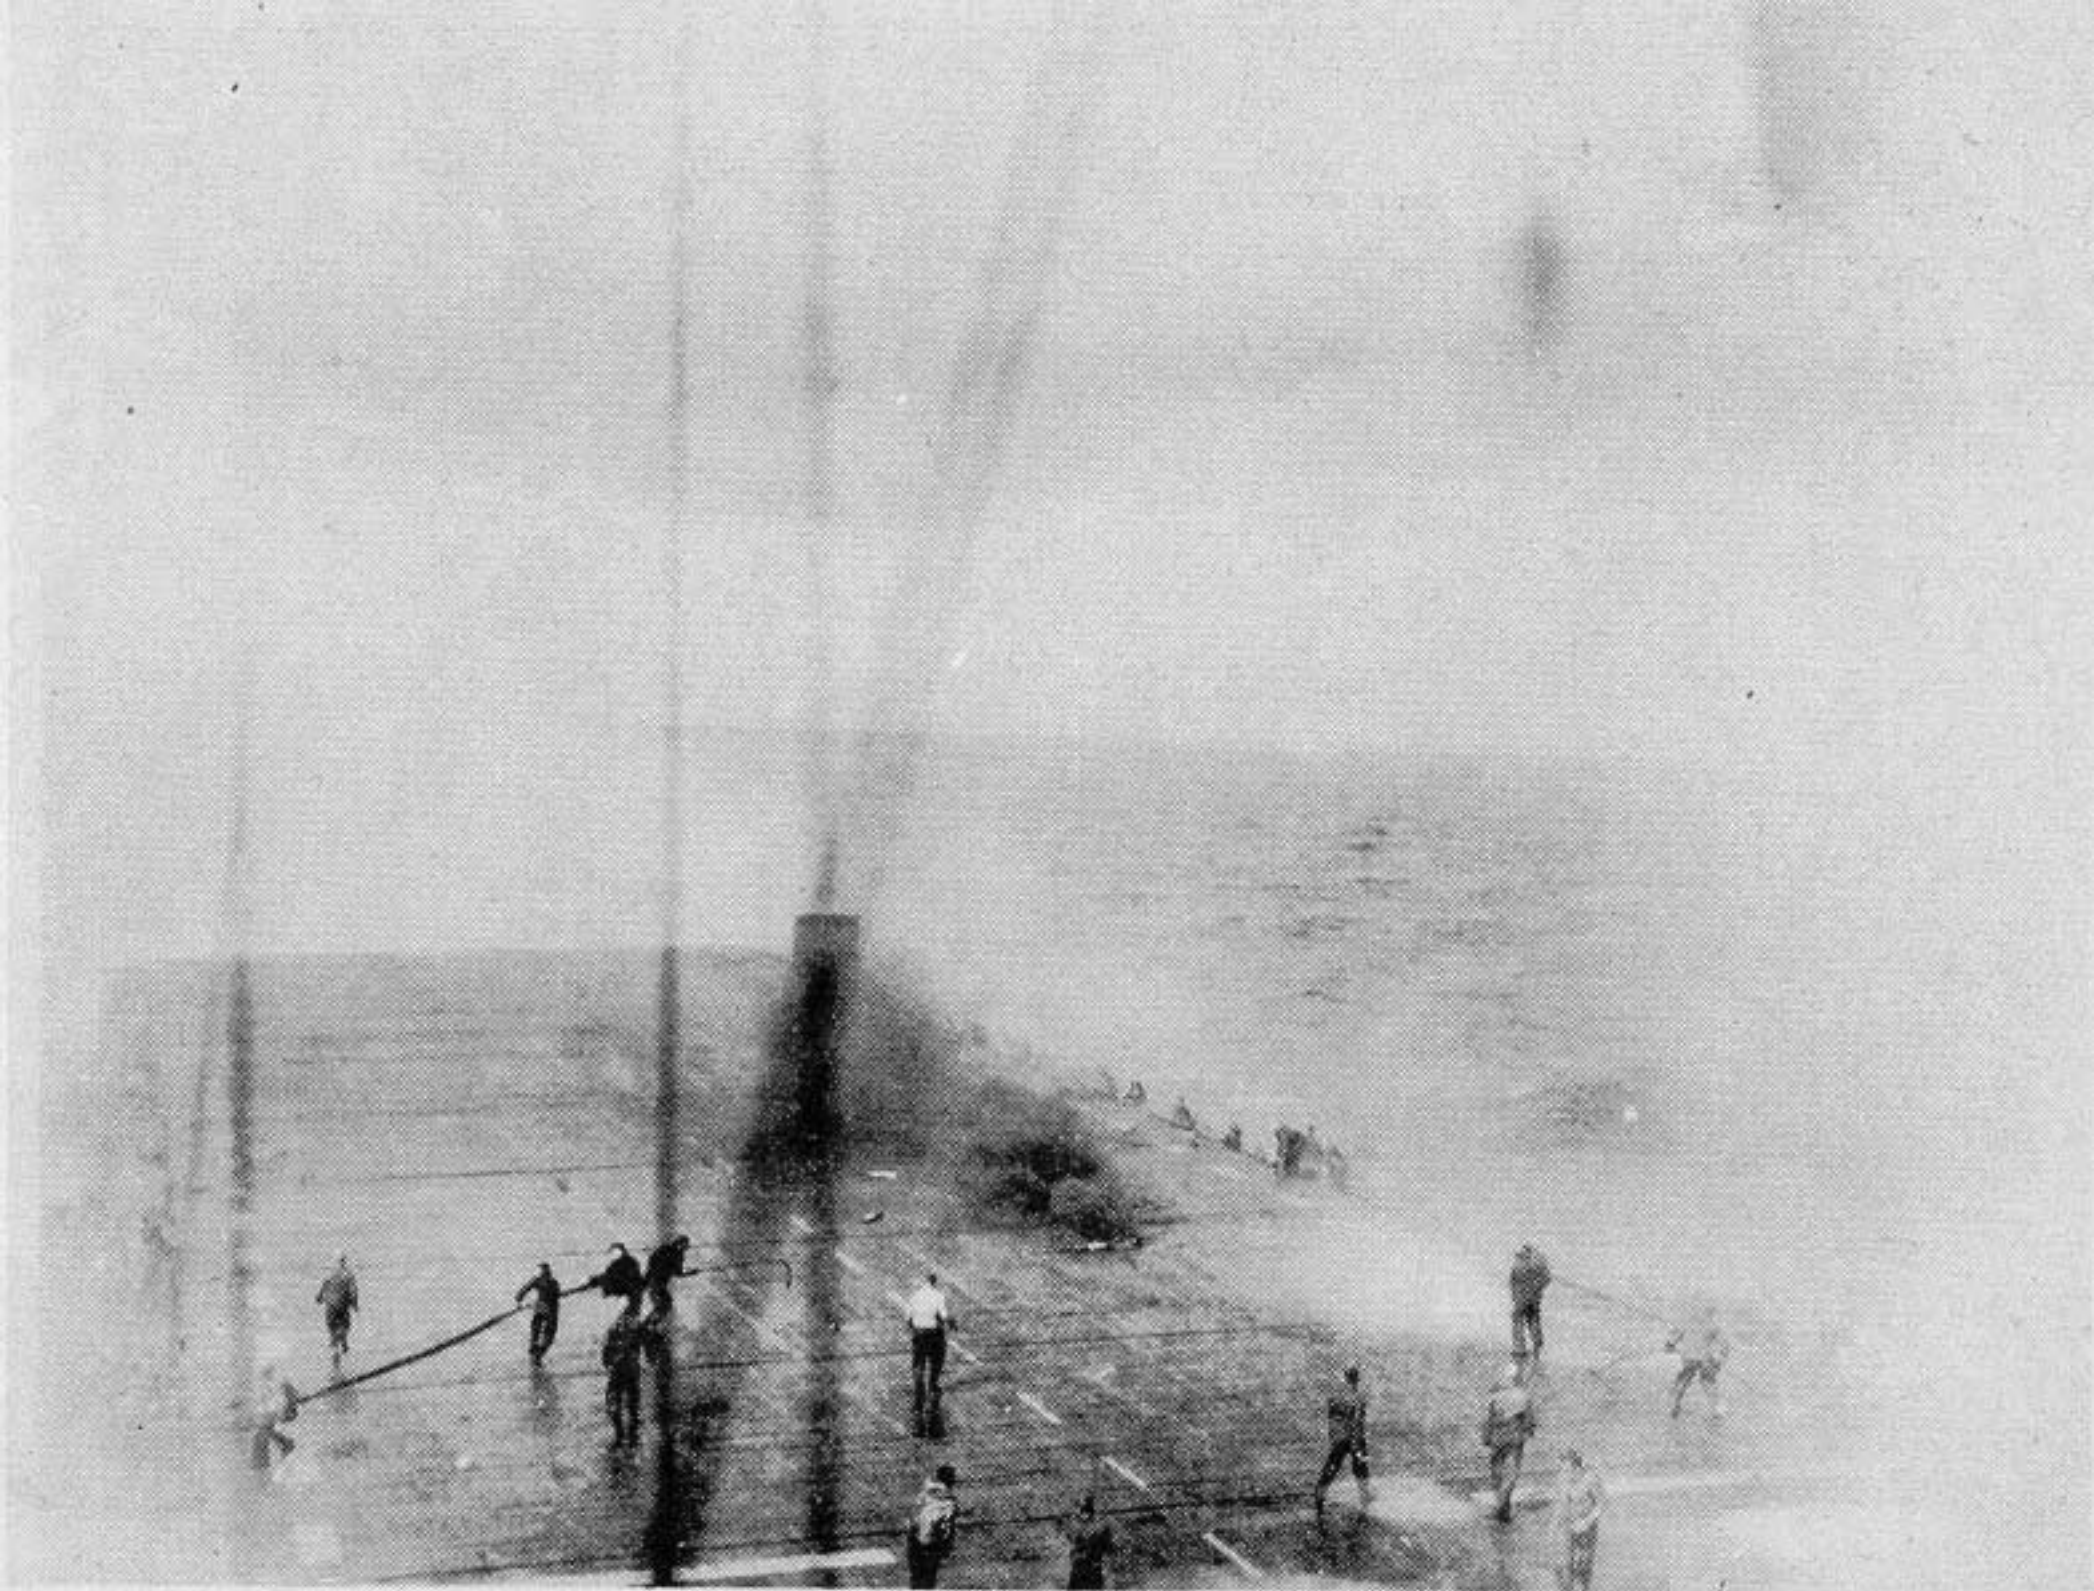
1. Black smoke emerging from bomb hole in flight deck.

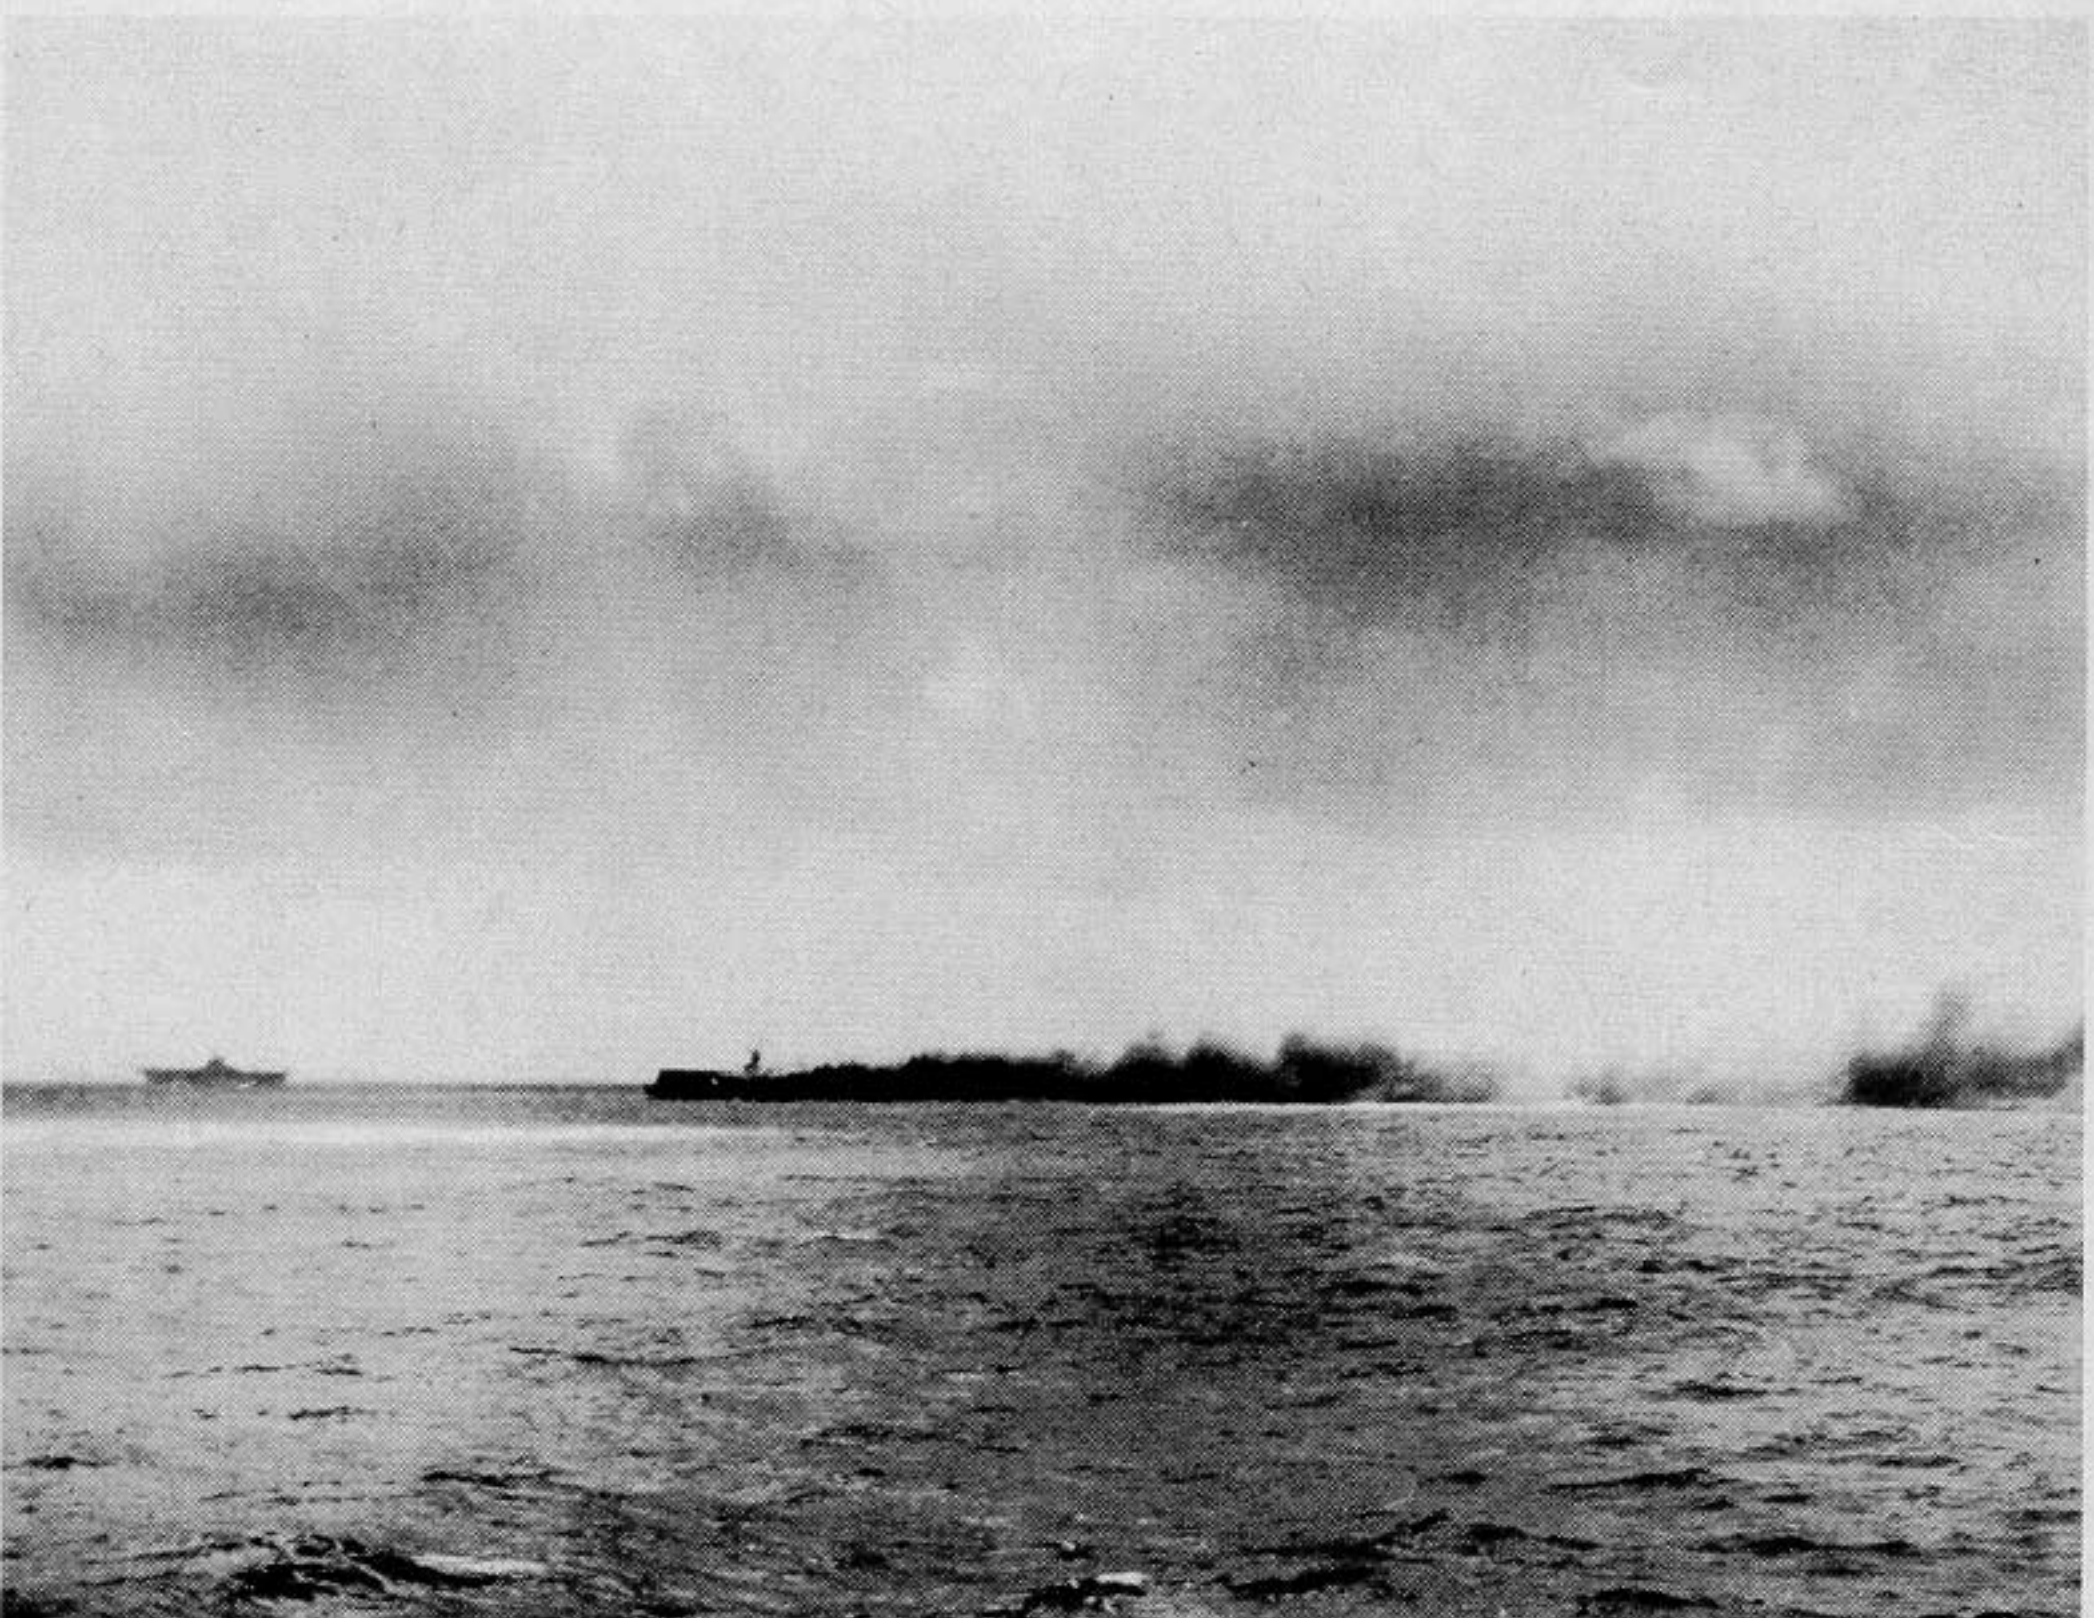
2. PRINCETON about two minutes after bomb hit. Note smoke on the port side which was drawn into the engineering spaces through the ventilation supply intakes.

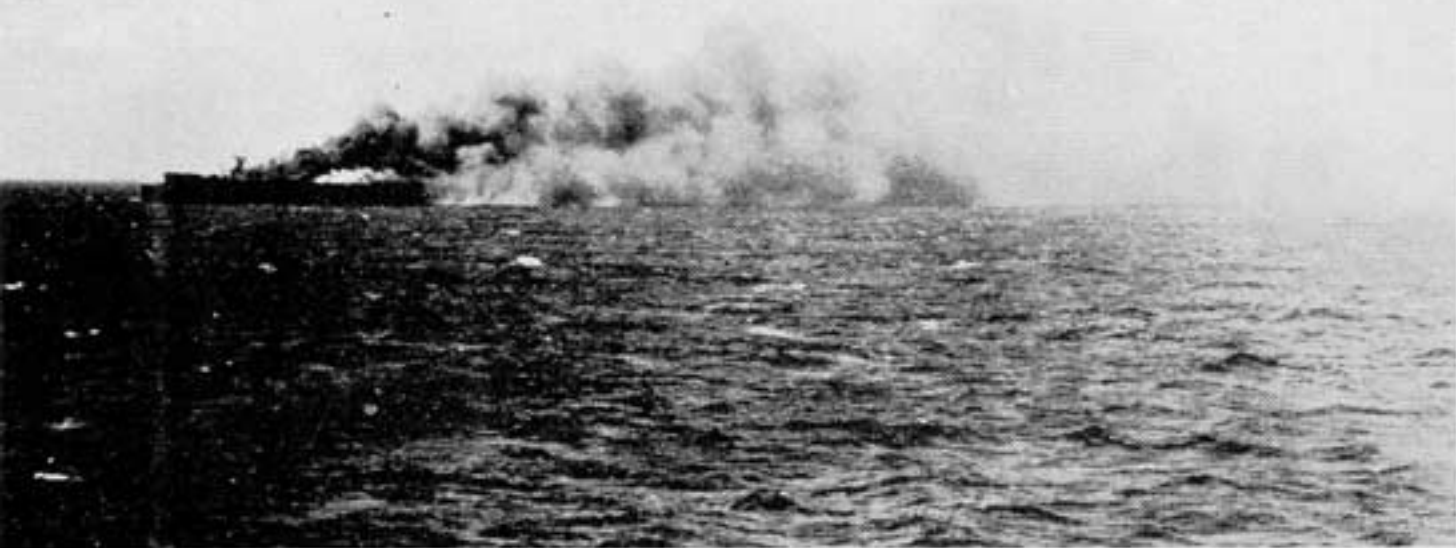
3. PRINCETON at about 0953. Fire raging aft. Ship has turned to put wind 45 degrees on port bow. Smoke appears to be blowing clear of the ventilation supply intakes on the port side.

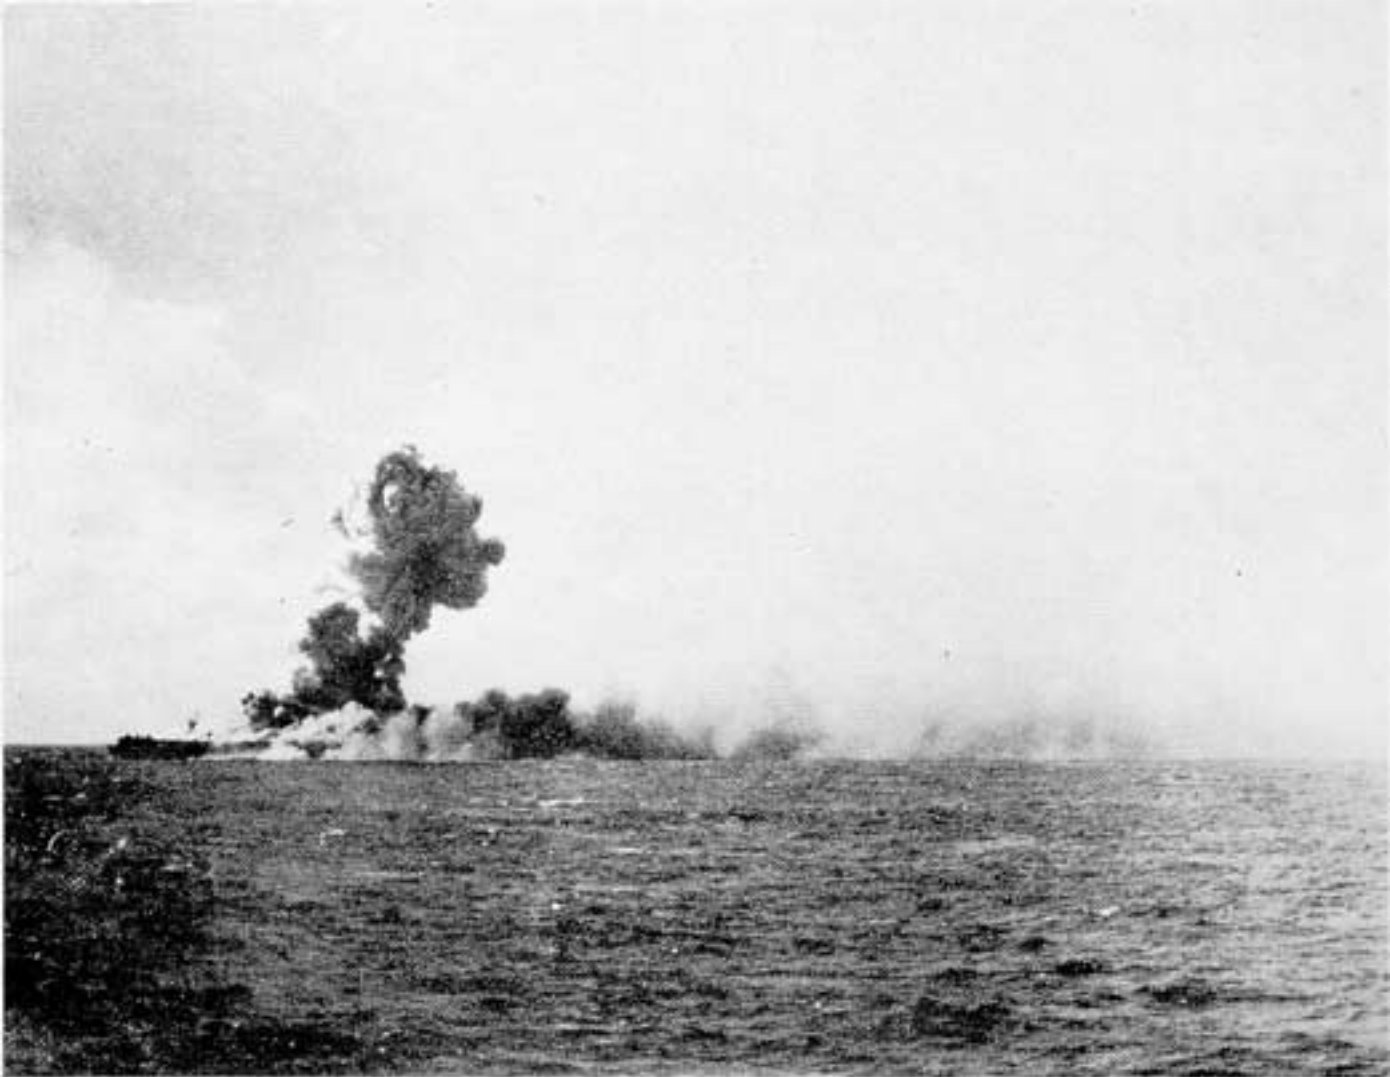
5. First major explosion in hangar at 1002.

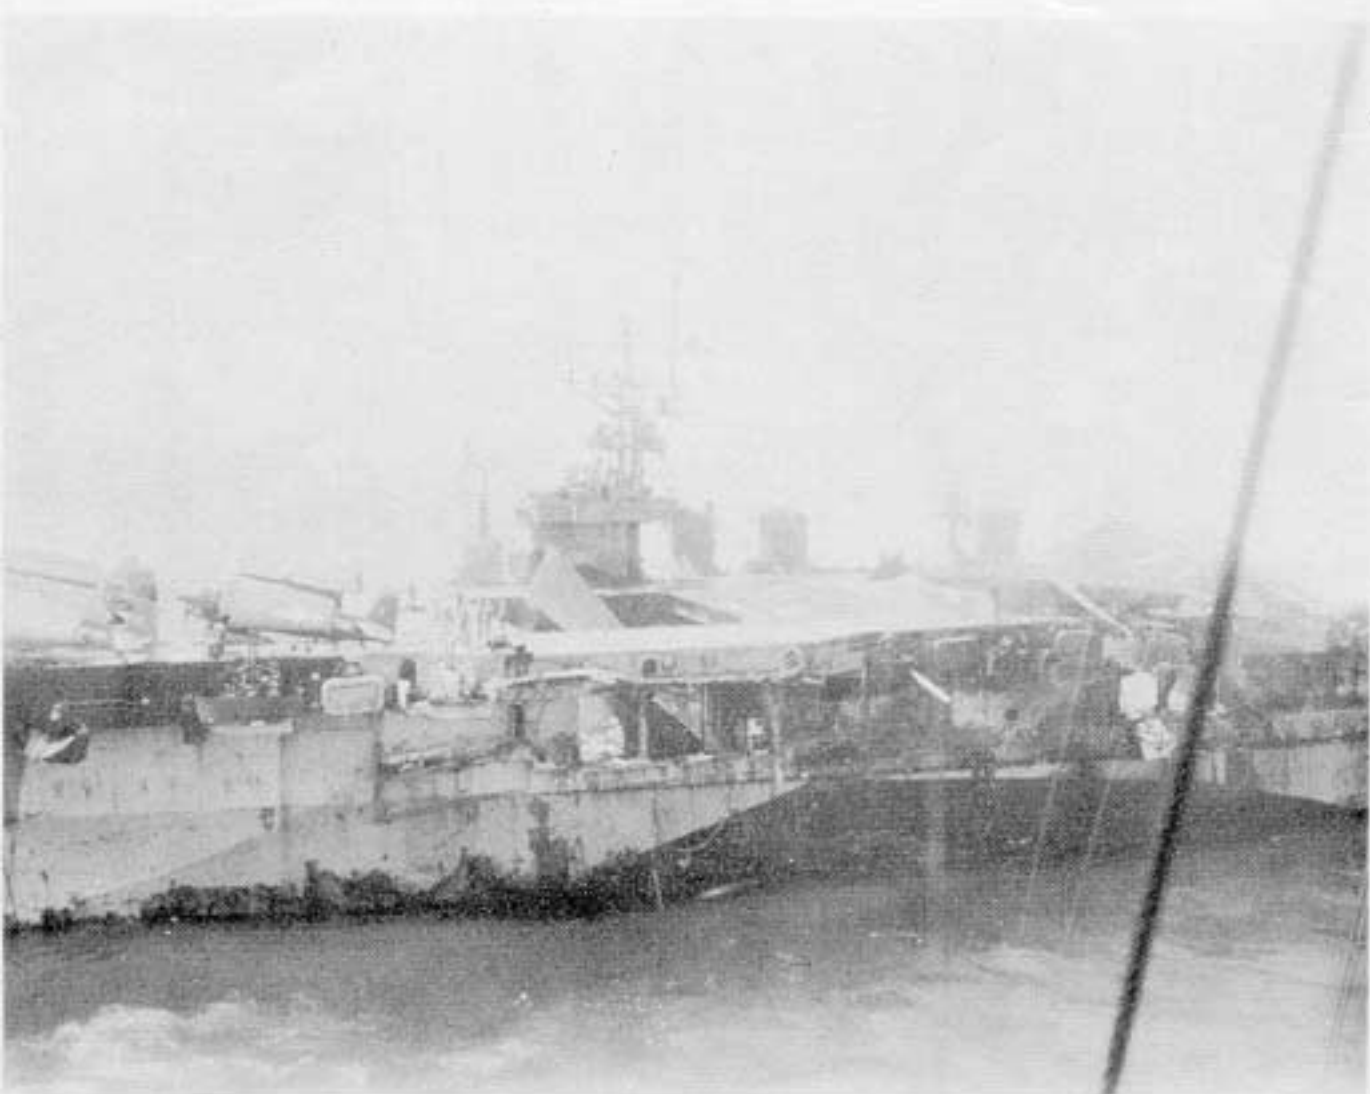
6. General view of forward damage from explosions in hangar. Note beam on flight deck crane, inclined forward elevator platform, hole blown in flight deck and panels blown out on the port side of the hangar.

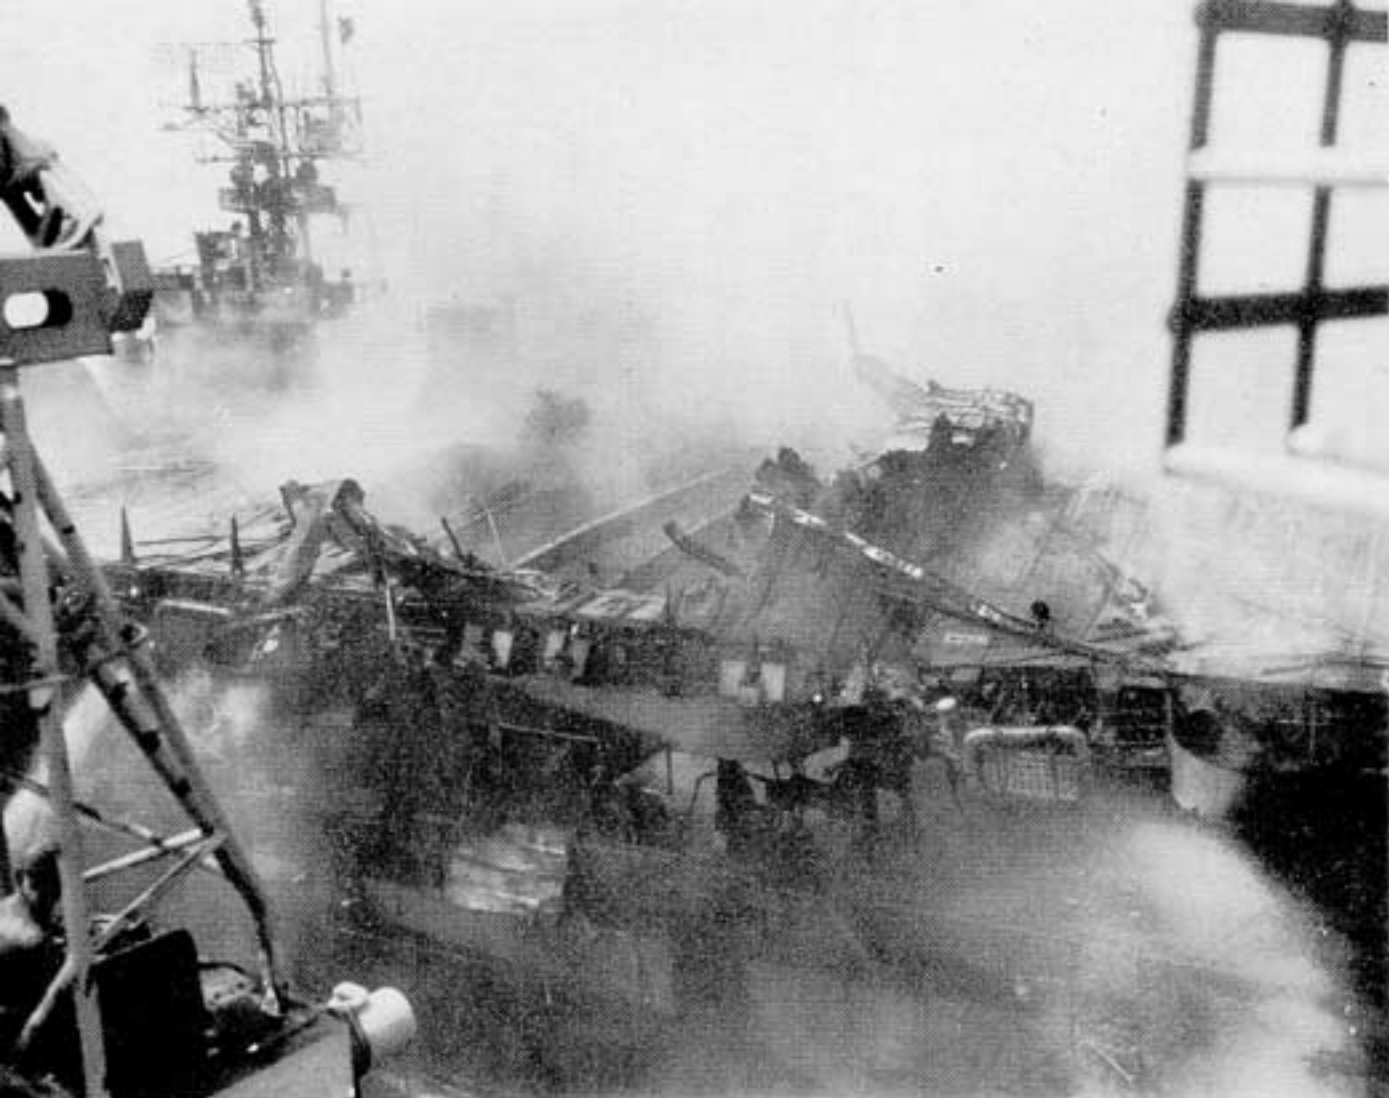
7. Close-up view of hole in flight deck between frames 68 and 80. Note transverse bents still intact but bowed upward.

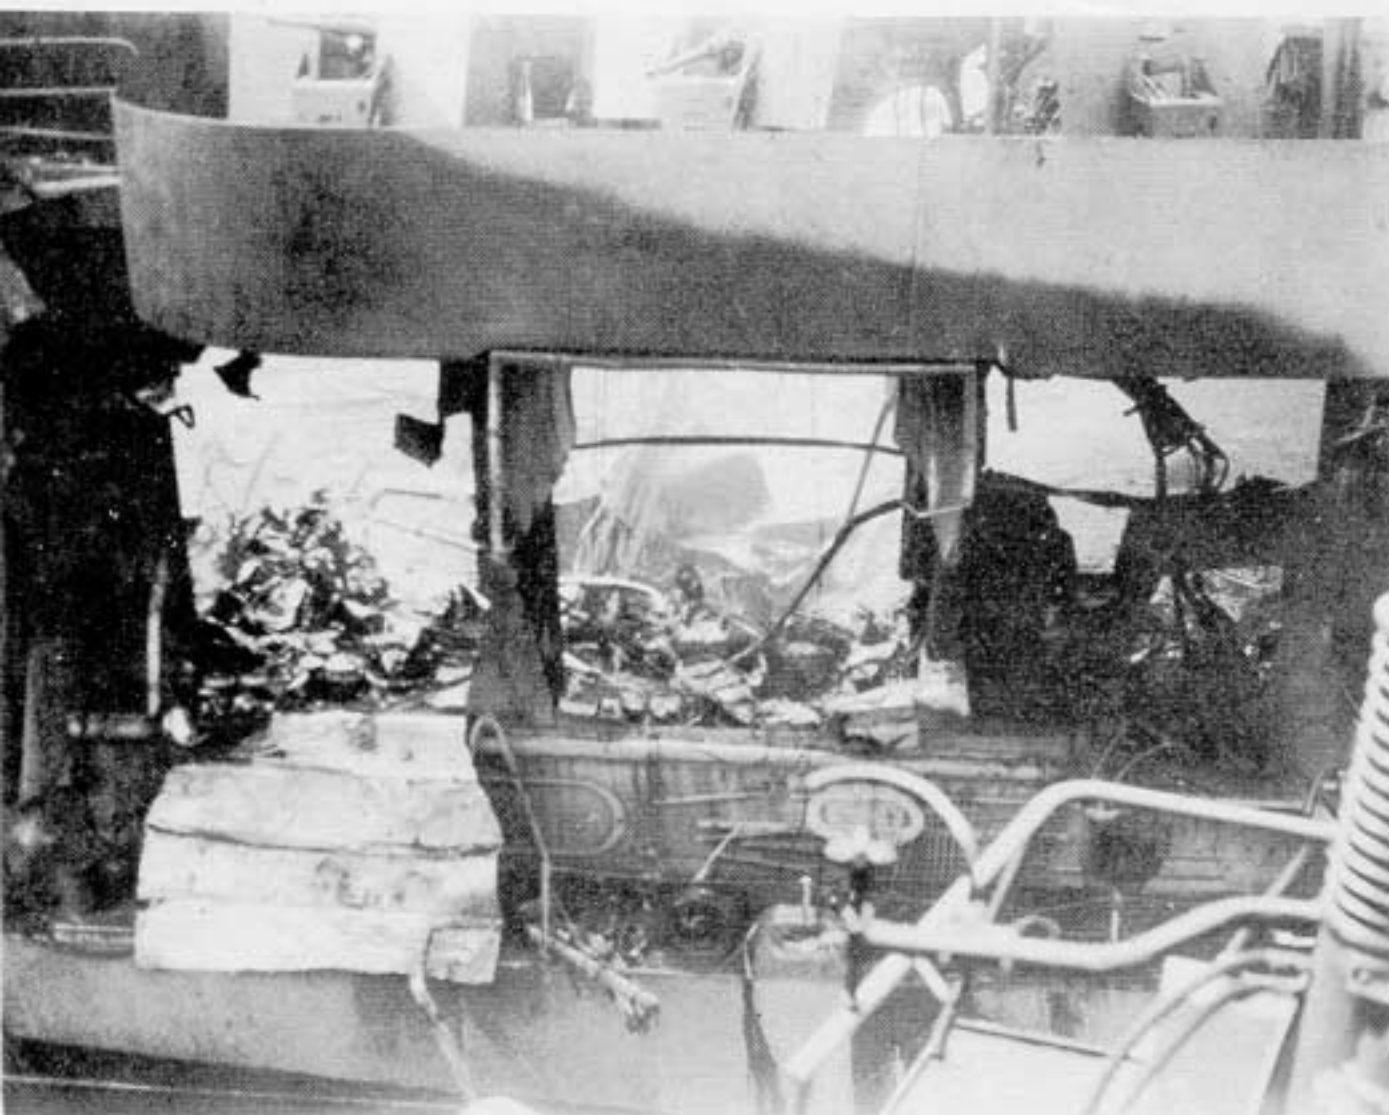
8. View of damage to hangar deck seen through blown-out side of hangar. Note crumpled area of hangar deck centered at about frame 78.

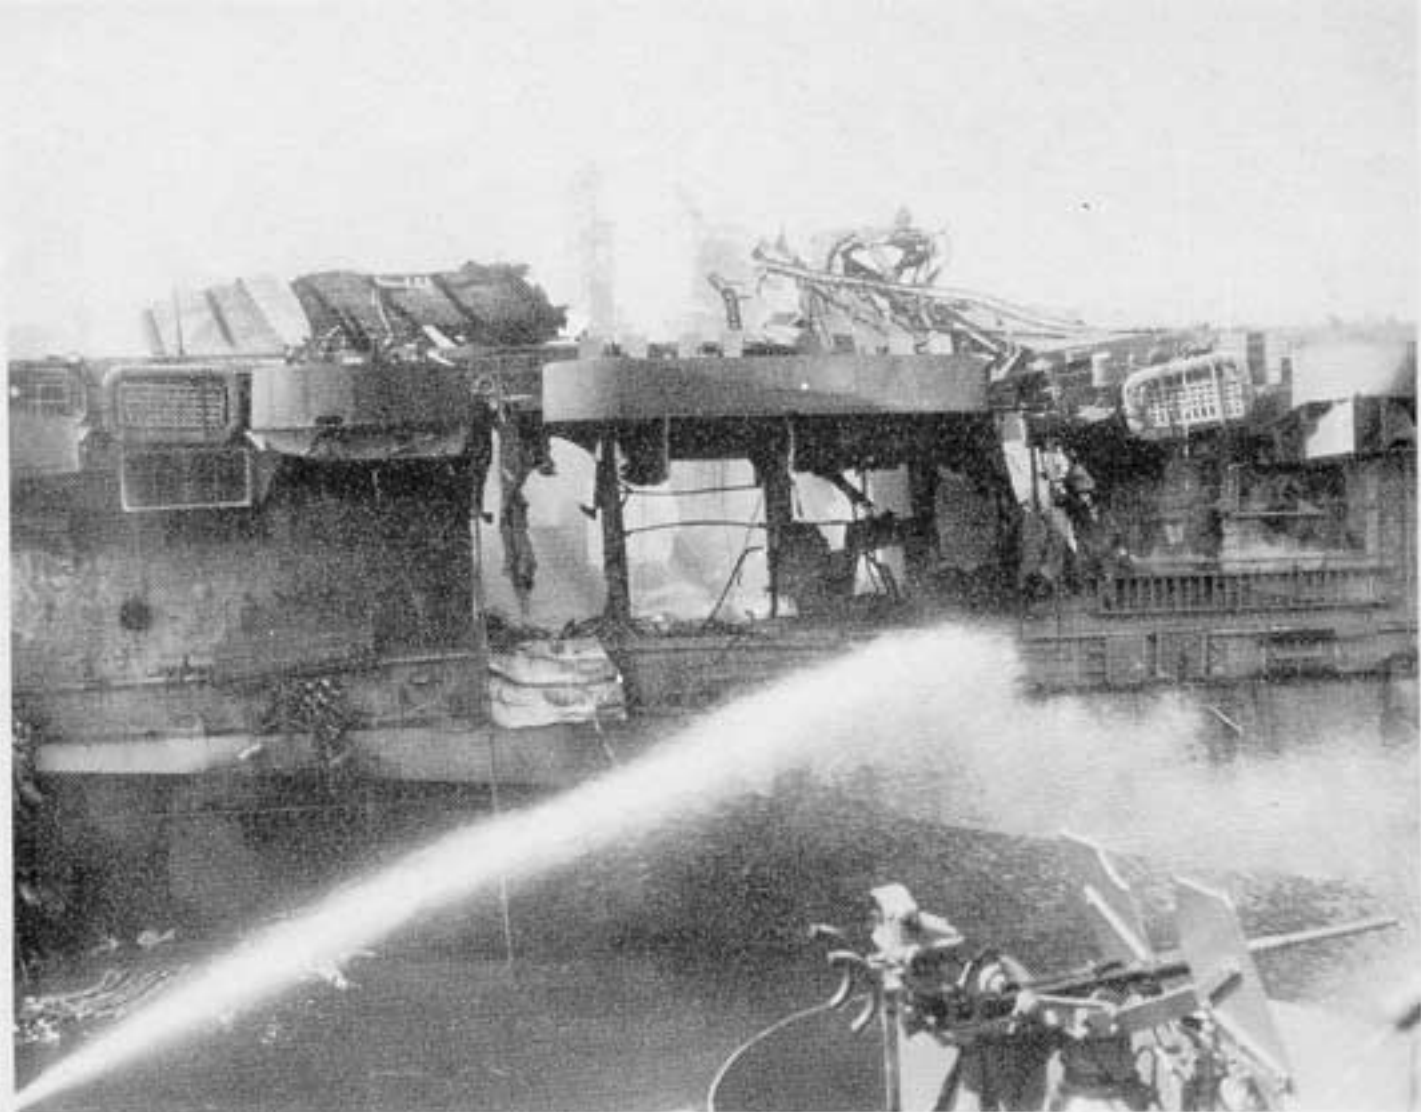
9. View of damage to port side of hangar between frames 74 and 86. Note similar damage to starboard side of hangar.

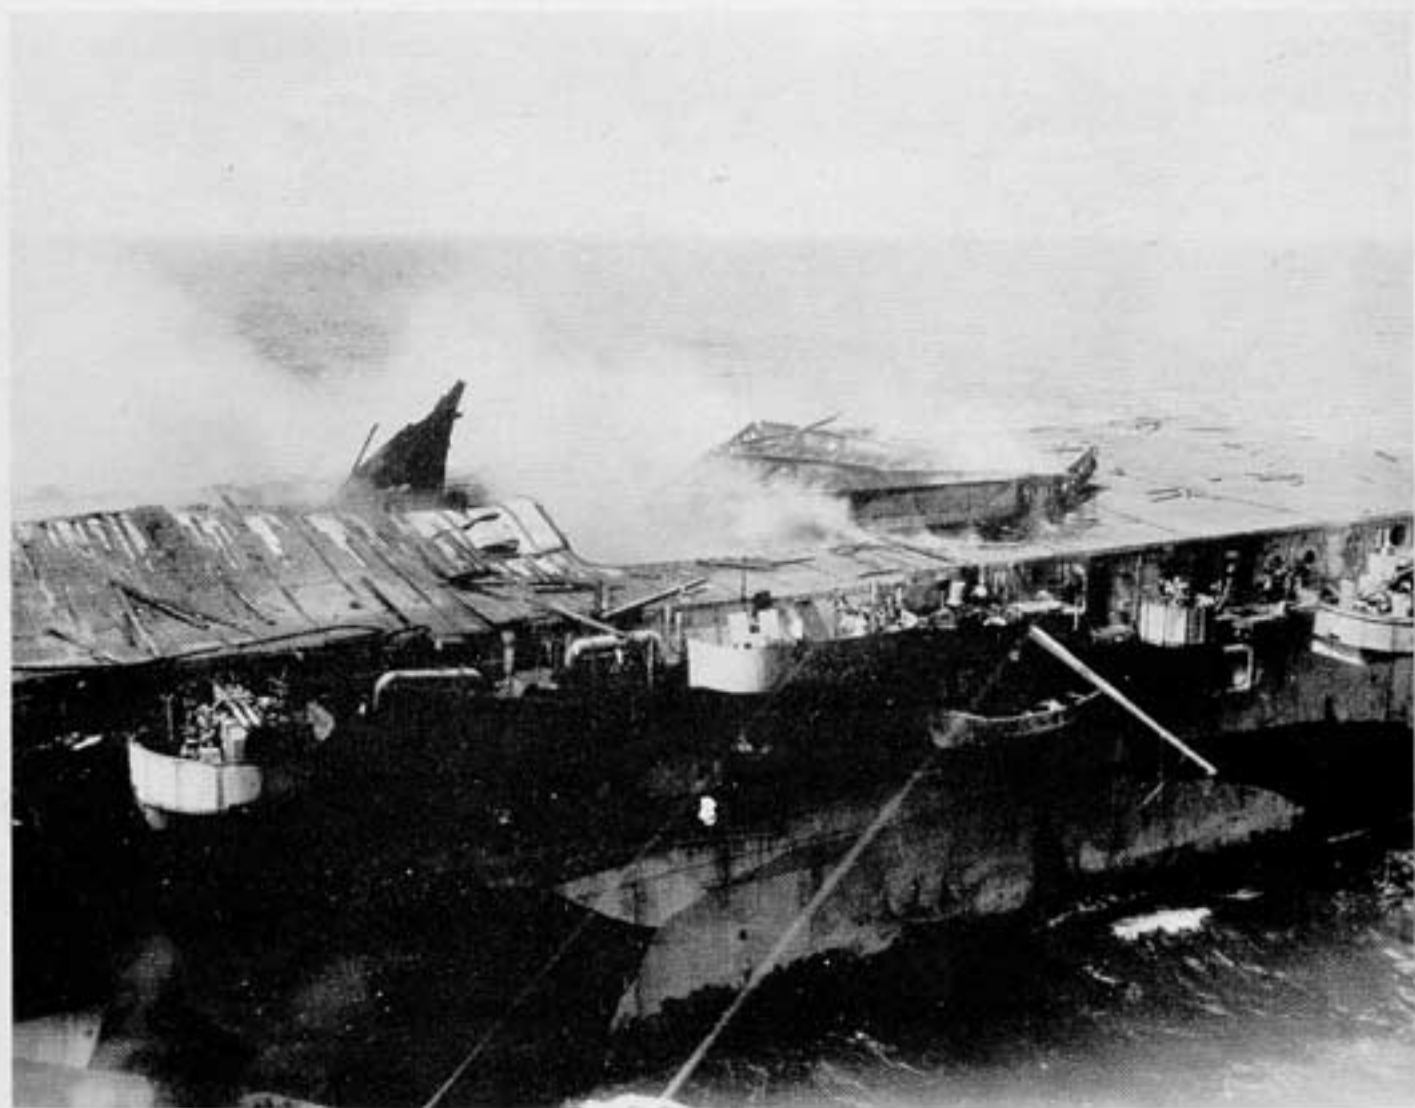
10. View of damage to after end of flight deck as a result of explosions in hangar. Note overturned elevator platform.

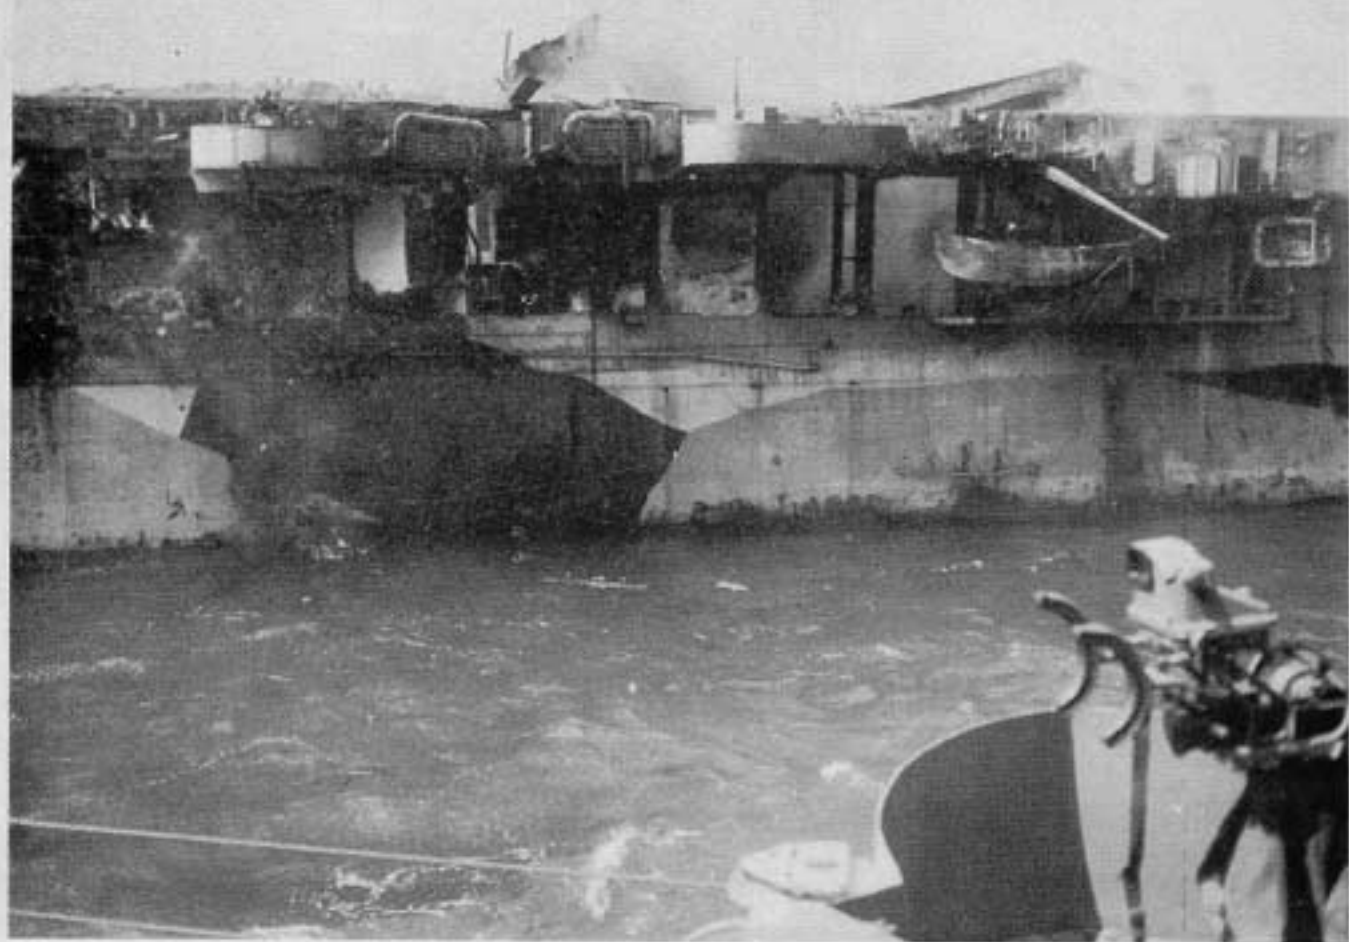
11. View of after port side of PRINCETON. Note hangar roller curtains demolished, panel between frames 110 and 113 blown out and hole in panel between frames 115 and 118.

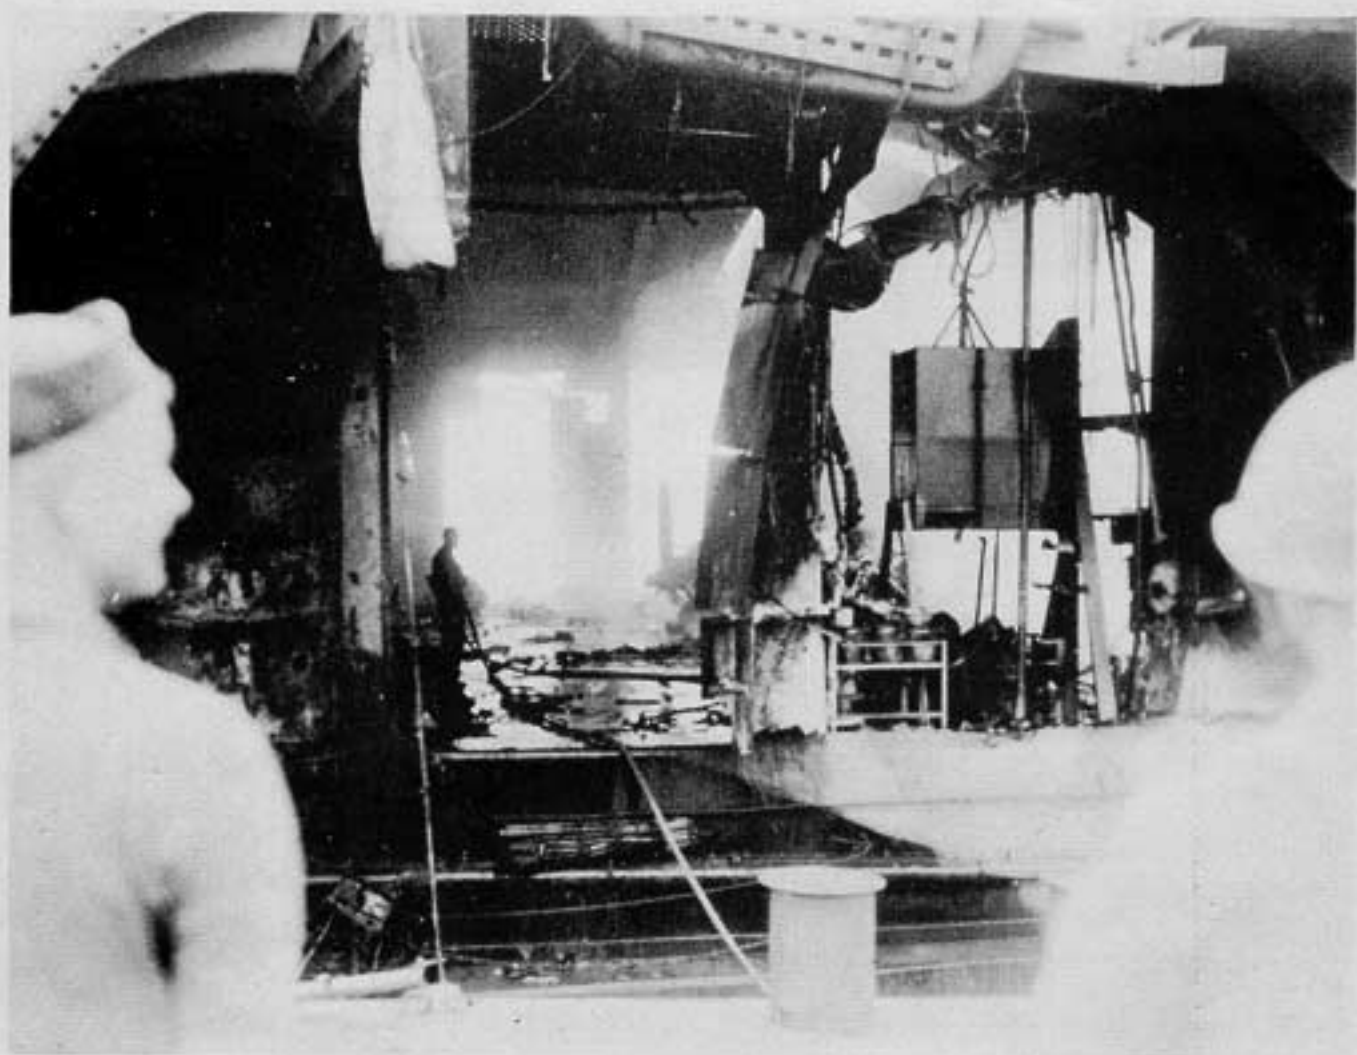
12. Close-up view of port side showing hangar roller curtain opening between frames 107 and 110 and blown-out panel between frames 110 and 113. Note similar damage to starboard side. One of the two airplane engines not consumed by the fire or demolished by the explosions in the hangar can be seen.

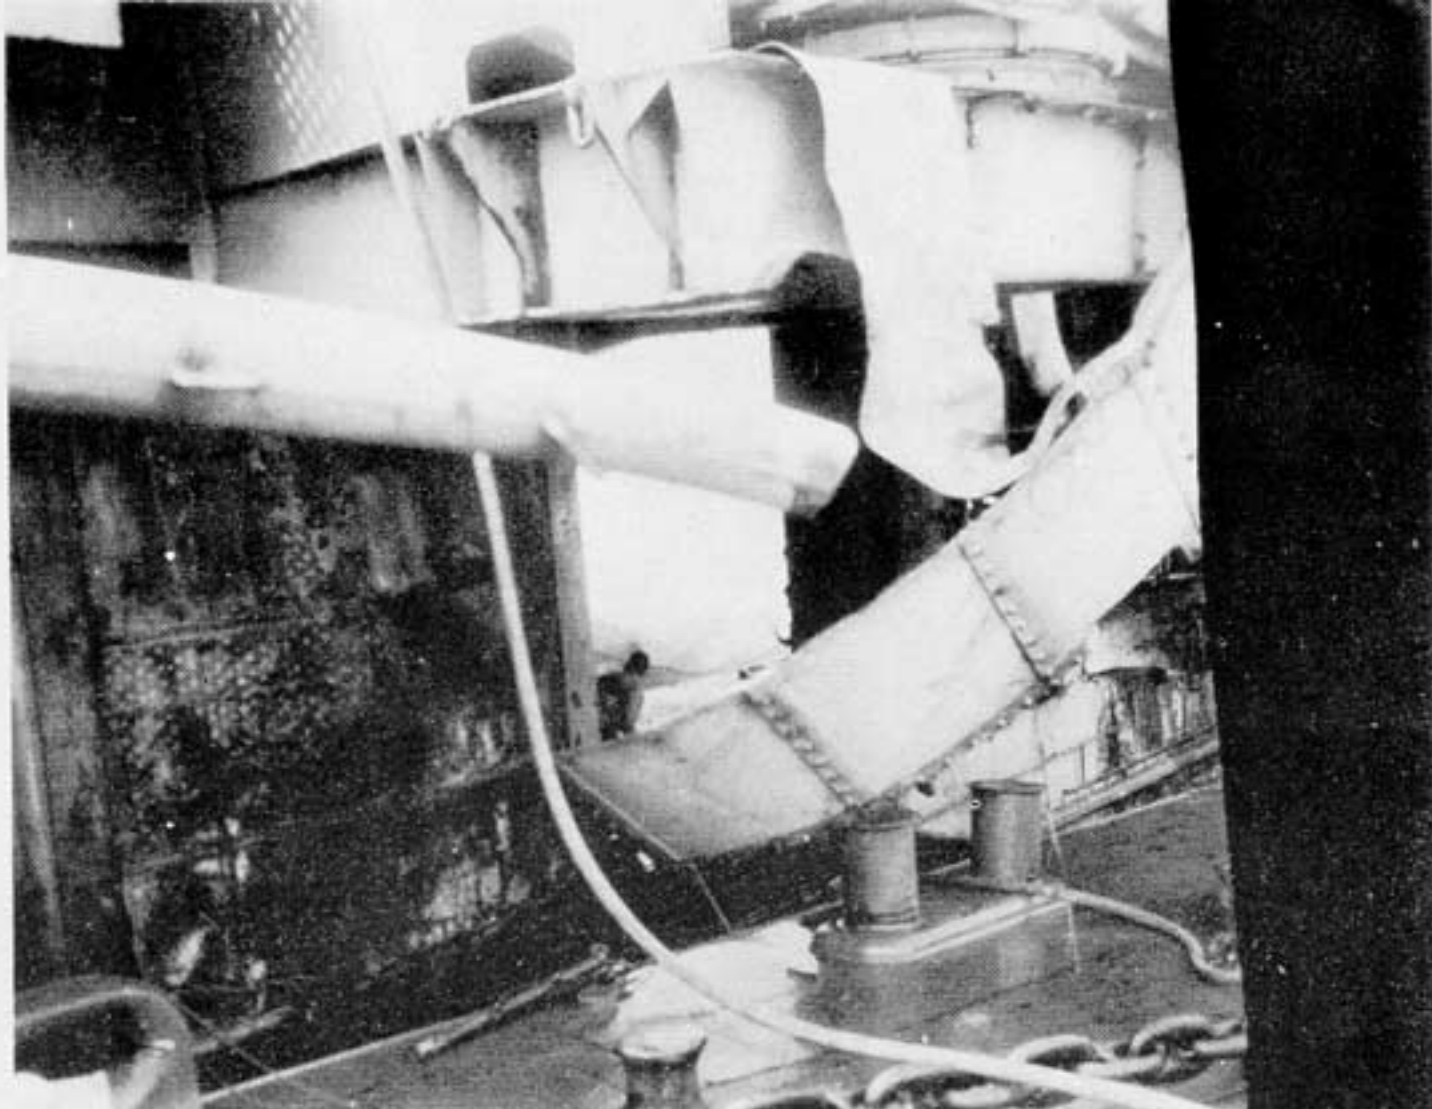
13. Hole blown in hangar deck at about frame 114. Gun sponson was damaged by ships alongside.

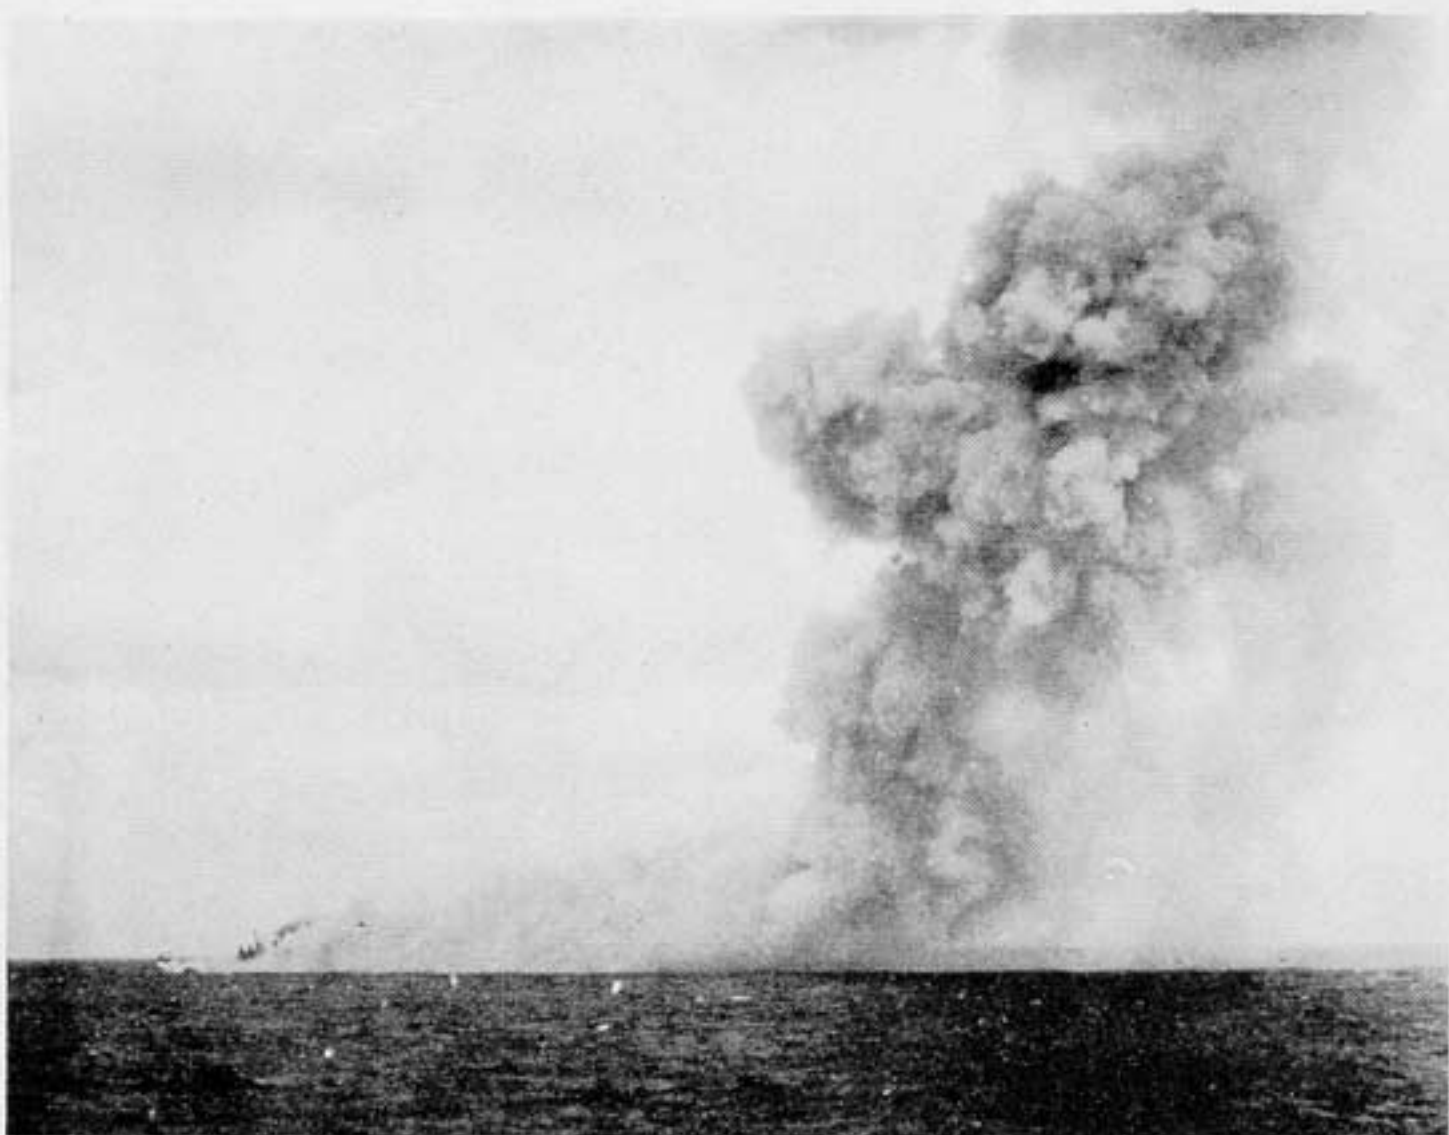
14. Smoke from detonation of bombs stowed in torpedo stowage. BIRMINGHAM visible at left edge of smoke.
