U. S. S. PRINCETON (CVL23)

LOSS IN ACTION

BATTLE FOR LEYTE GULF

WAR DAMAGE REPORT No. 62

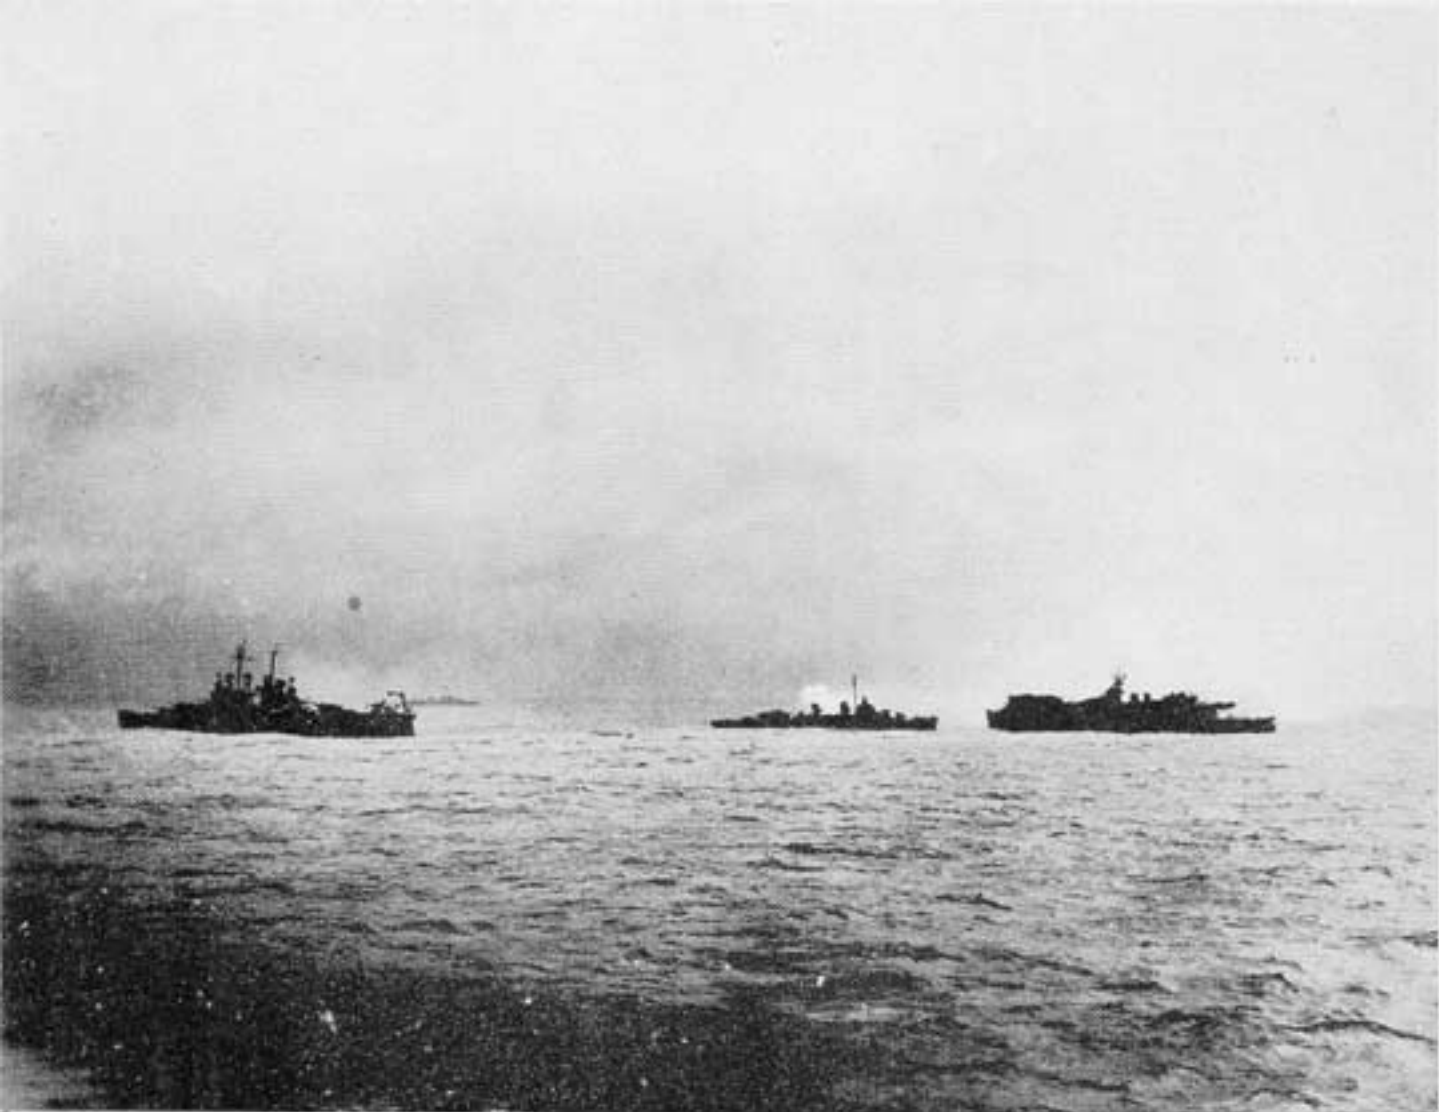
15. PRINCETON after detonation of bombs in torpedo stowage.

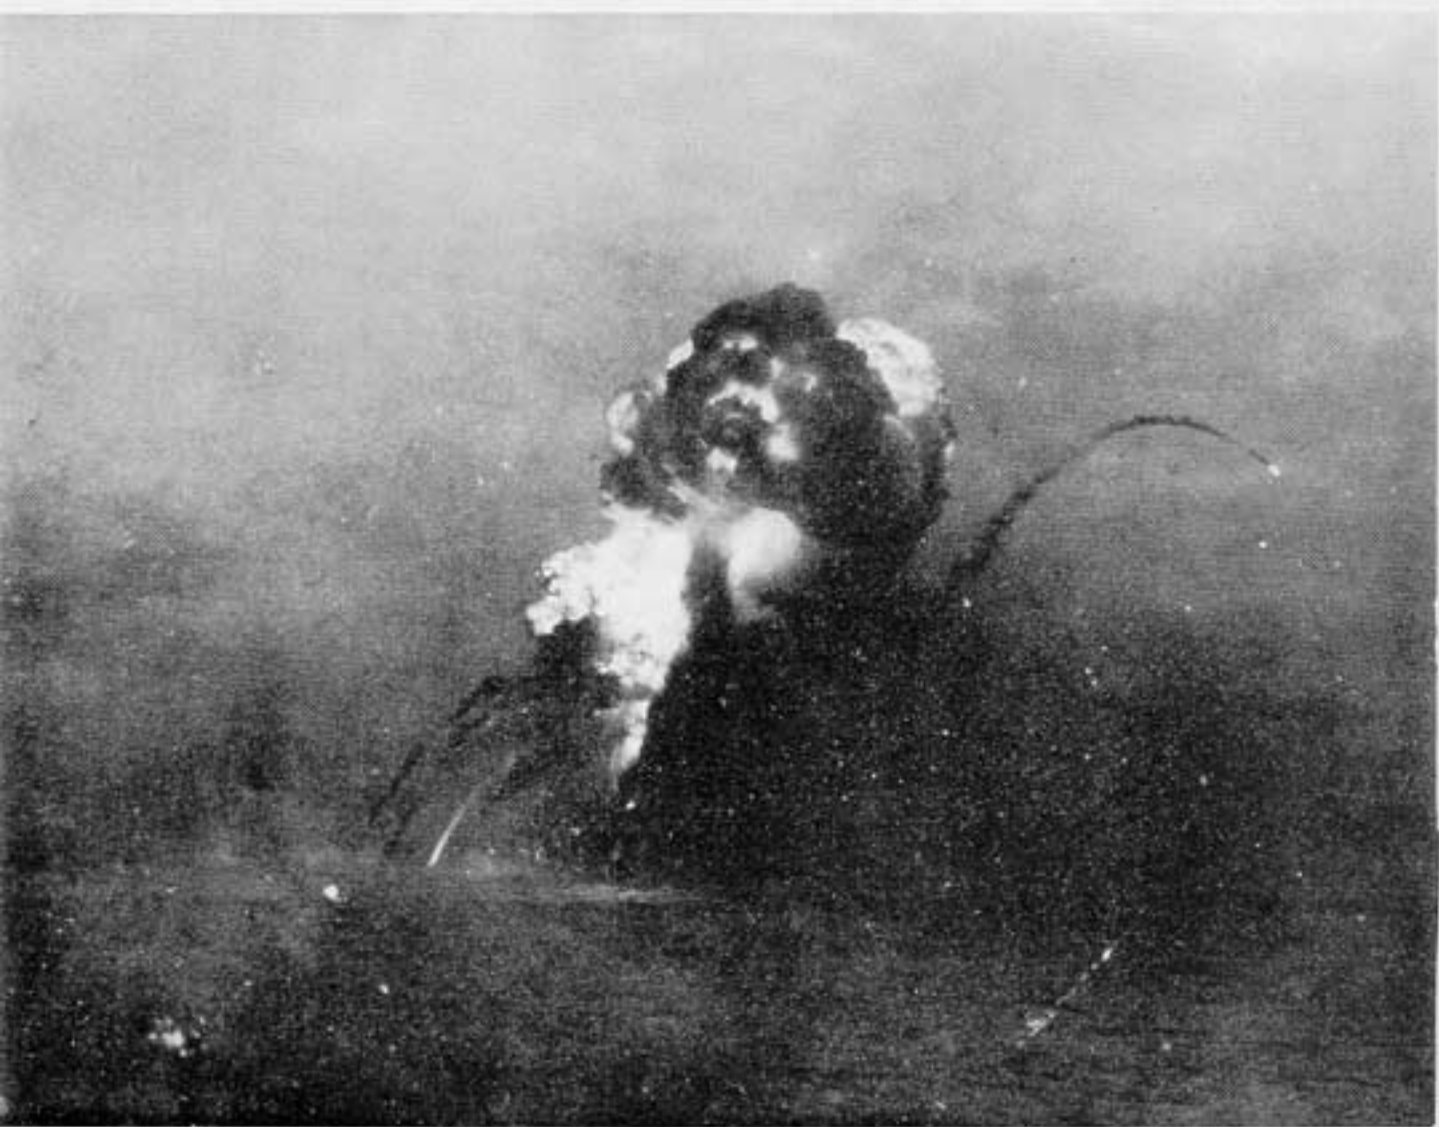
16. Explosion of forward bomb magazines initiated by torpedo hits. PRINCETON had sunk by the time smoke cleared.
